optical**CON** QUAD | **Technical Paper**

Mechanical, electrical and optical tests applied to the opticalCON transmission system for Pro Audio / Video and Broadcast purposes with main focus on changes in attenuation.

This documentation describes the results of the test series conducted at Neutrik AG, University of Applied Sciences of Technology Buchs NTB

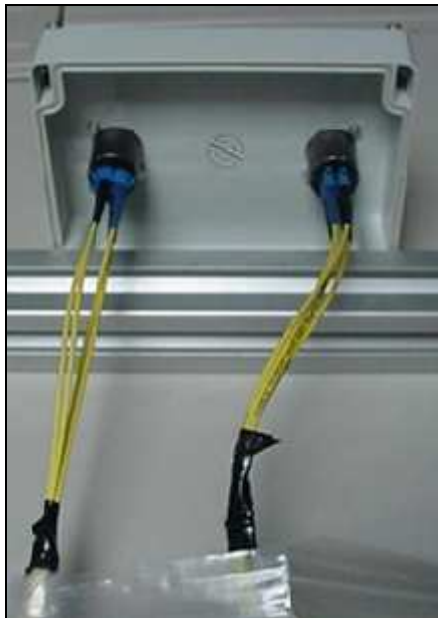
Fig. 2.b

The measurement cables are covered with a plastic bag to avoid pollution on powermeter.

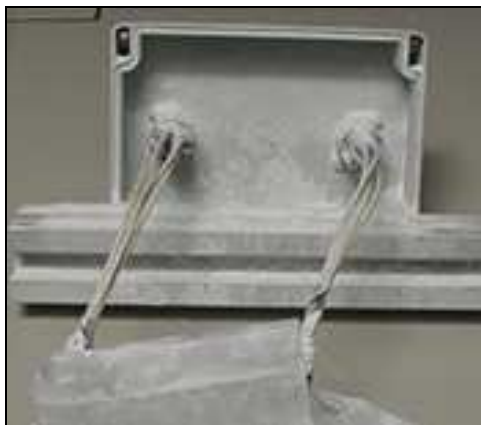
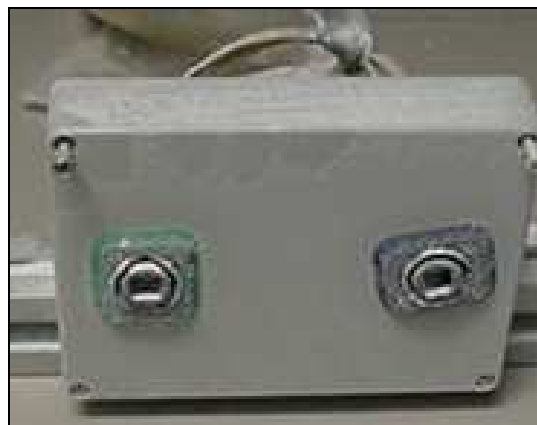
After dust test: The opticalCON QUAD chassis NO4FDW are completely covered with talcum particle on the front and rear side (fig. 2.d and 2.e). The measured attenuation (figure 2.a) establishes only small variation of the attenuation values after dust test.

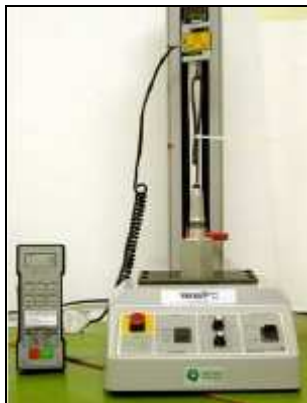
Fig 4.a

Full automatic cable retention test according IEC 61300-2-4
The pulling force went over >500 N

The opticalCON QUAD cable is tested and approved for > 500N without any quality and function adverse effects.

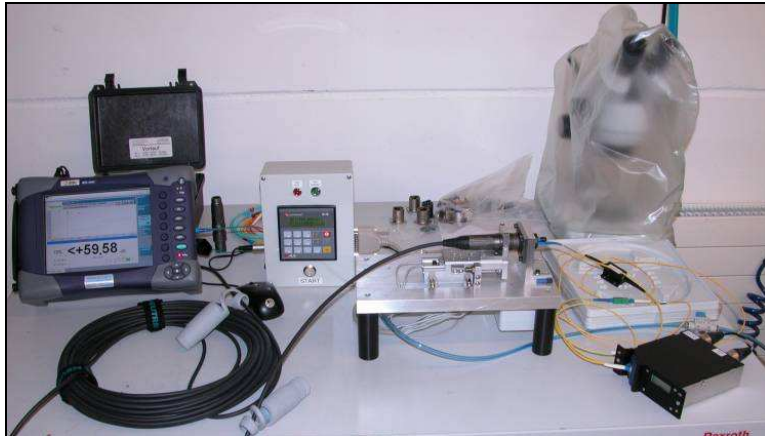
Fig. 7.a: measuring setup for durability and lifetime test

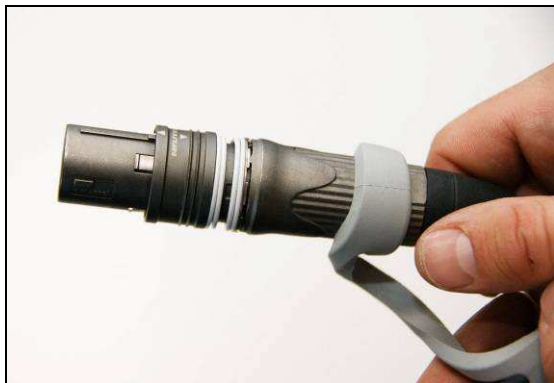
Fig. 7.g

No mechanical degradations on the opticalCON QUAD cable connector.

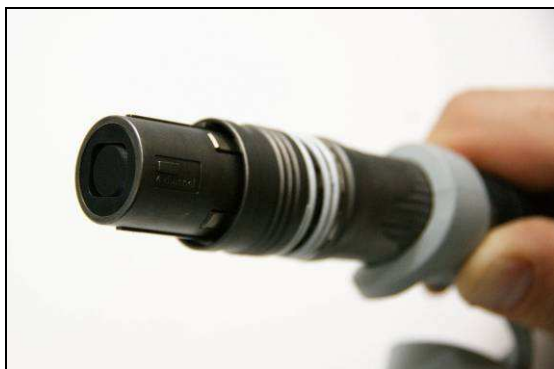
Fig. 7.h

Proper functionality of the shutter and locking mechanism

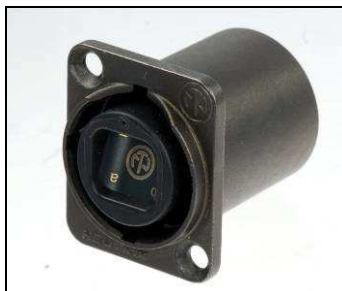
After 5000 mating cycles and temperature test the opticalCON chassis NO4FDW-R (figure 14) didn't show any significant deformations or mechanical malfunction. The greased O-ring didn't indicate any cracks or rough areas (figure 15).

Fig. 8: Test chassis NO4FDW-R

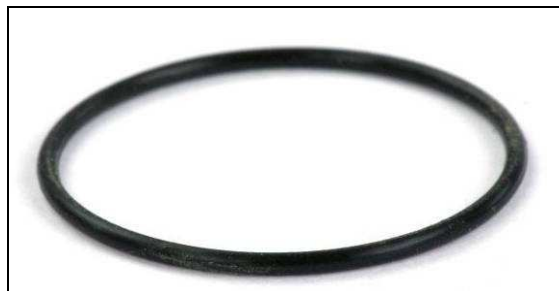
Fig. 9: O-ring after 5000 mating cycles
